DEPARTMENT OF TRANSPORTATION

Quality Assurance and Source Inspection

Contract #: 04-0120F4Cty: SF/ALA Rte: 80 PM: 13.2/13.9File #: 69.28**WELDING INSPECTION REPORT****Resident Engineer:**Siegenthaler, Peter**Address:** 333 Burma Road**City:** Oakland, CA 94607**Report No:** WIR-022447**Date Inspected:** 22-Mar-2011**Project Name:** SAS Superstructure**OSM Arrival Time:** 700**Prime Contractor:** American Bridge/Fluor Enterprises, a JV**OSM Departure Time:** 1900**Contractor:** Zhenhua Port Machinery Company, Ltd (ZPMC), Changxing Island **Location:** Shanghai, China**CWI Name:** Lv Li Qing**CWI Present:** Yes No**Inspected CWI report:** Yes No N/A**Rod Oven in Use:** Yes No N/A**Electrode to specification:** Yes No N/A**Weld Procedures Followed:** Yes No N/A**Qualified Welders:** Yes No N/A**Verified Joint Fit-up:** Yes No N/A**Approved Drawings:** Yes No N/A**Approved WPS:** Yes No N/A**Delayed / Cancelled:** Yes No N/A**Bridge No:** 34-0006**Component:** OBG**Summary of Items Observed:**

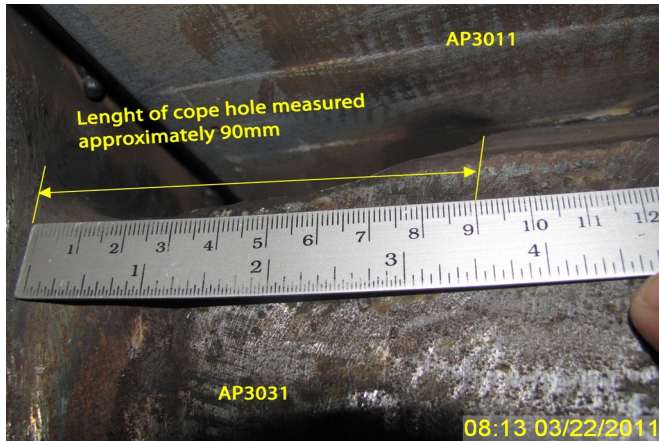
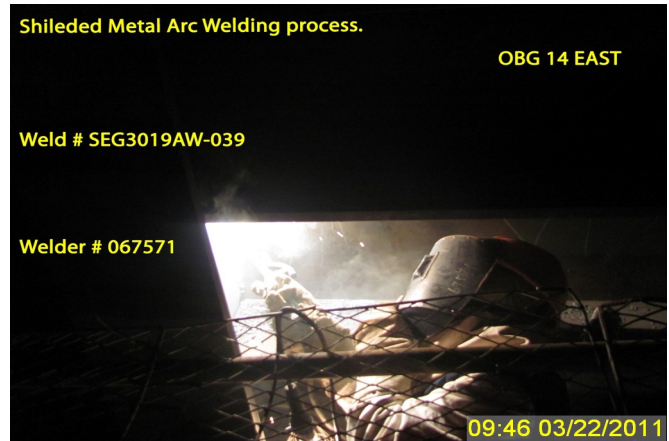
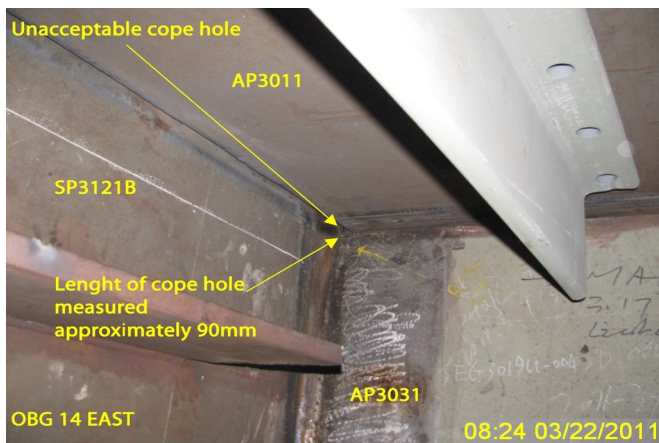
During the random visual inspection of the AP3031 in OBG 14 east this QA Inspector observed the cope hole on AP3031 at the intersection of the AP3011 and SP3121B was unacceptable. The radius of the cope hole had shown 30mm as per shop drawing. The dimension cope hole measured 30mm X 90mm, regarding this issue this QA Inspector informed to ZPMC QC (Wang xu), ABF QA and QA lead (CT) as per ZPMC QC they will make required document and performed buttering to achieve actual size of the cope hole. See attached photo for additional information.
